Creek Maintenance Summary Report
Sleepy Hollow Creek Homeowners Association
San Anselmo, California
June 2013

Prepared for:
SLEEPY HOLLOW HOMEOWNERS ASSOCIATION

Prepared by:
Matt Smeltzer, P.E.
Geomorphologist/Hydrologist
CA Civil Engineer #71671

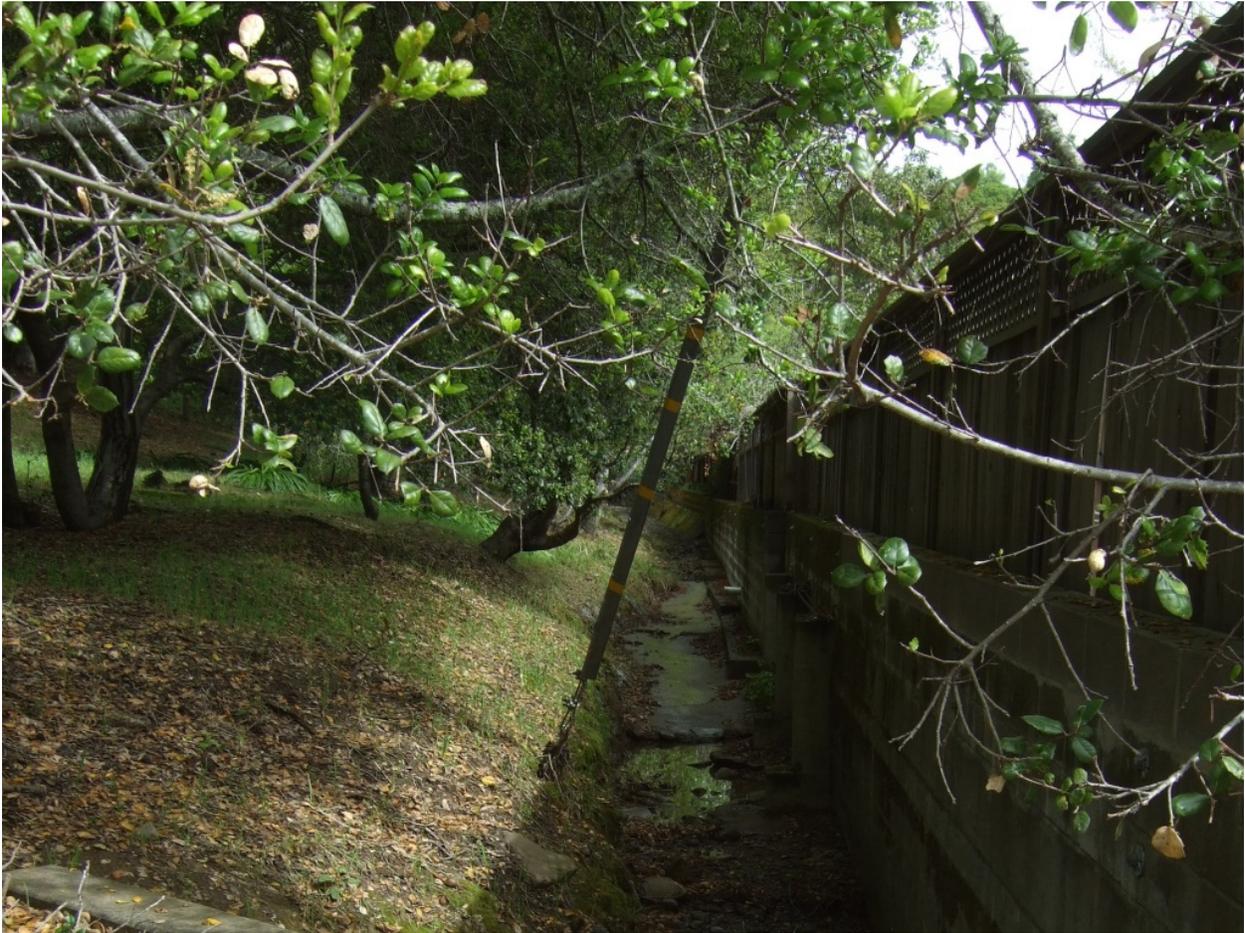
Stormwater drainage channel looking north from Van Winkle Drive near Manitou Drive Intersection
